# Barn Trans

A steel catwalk holds up the roof while opening up the space below

BY KILEY JACQUES

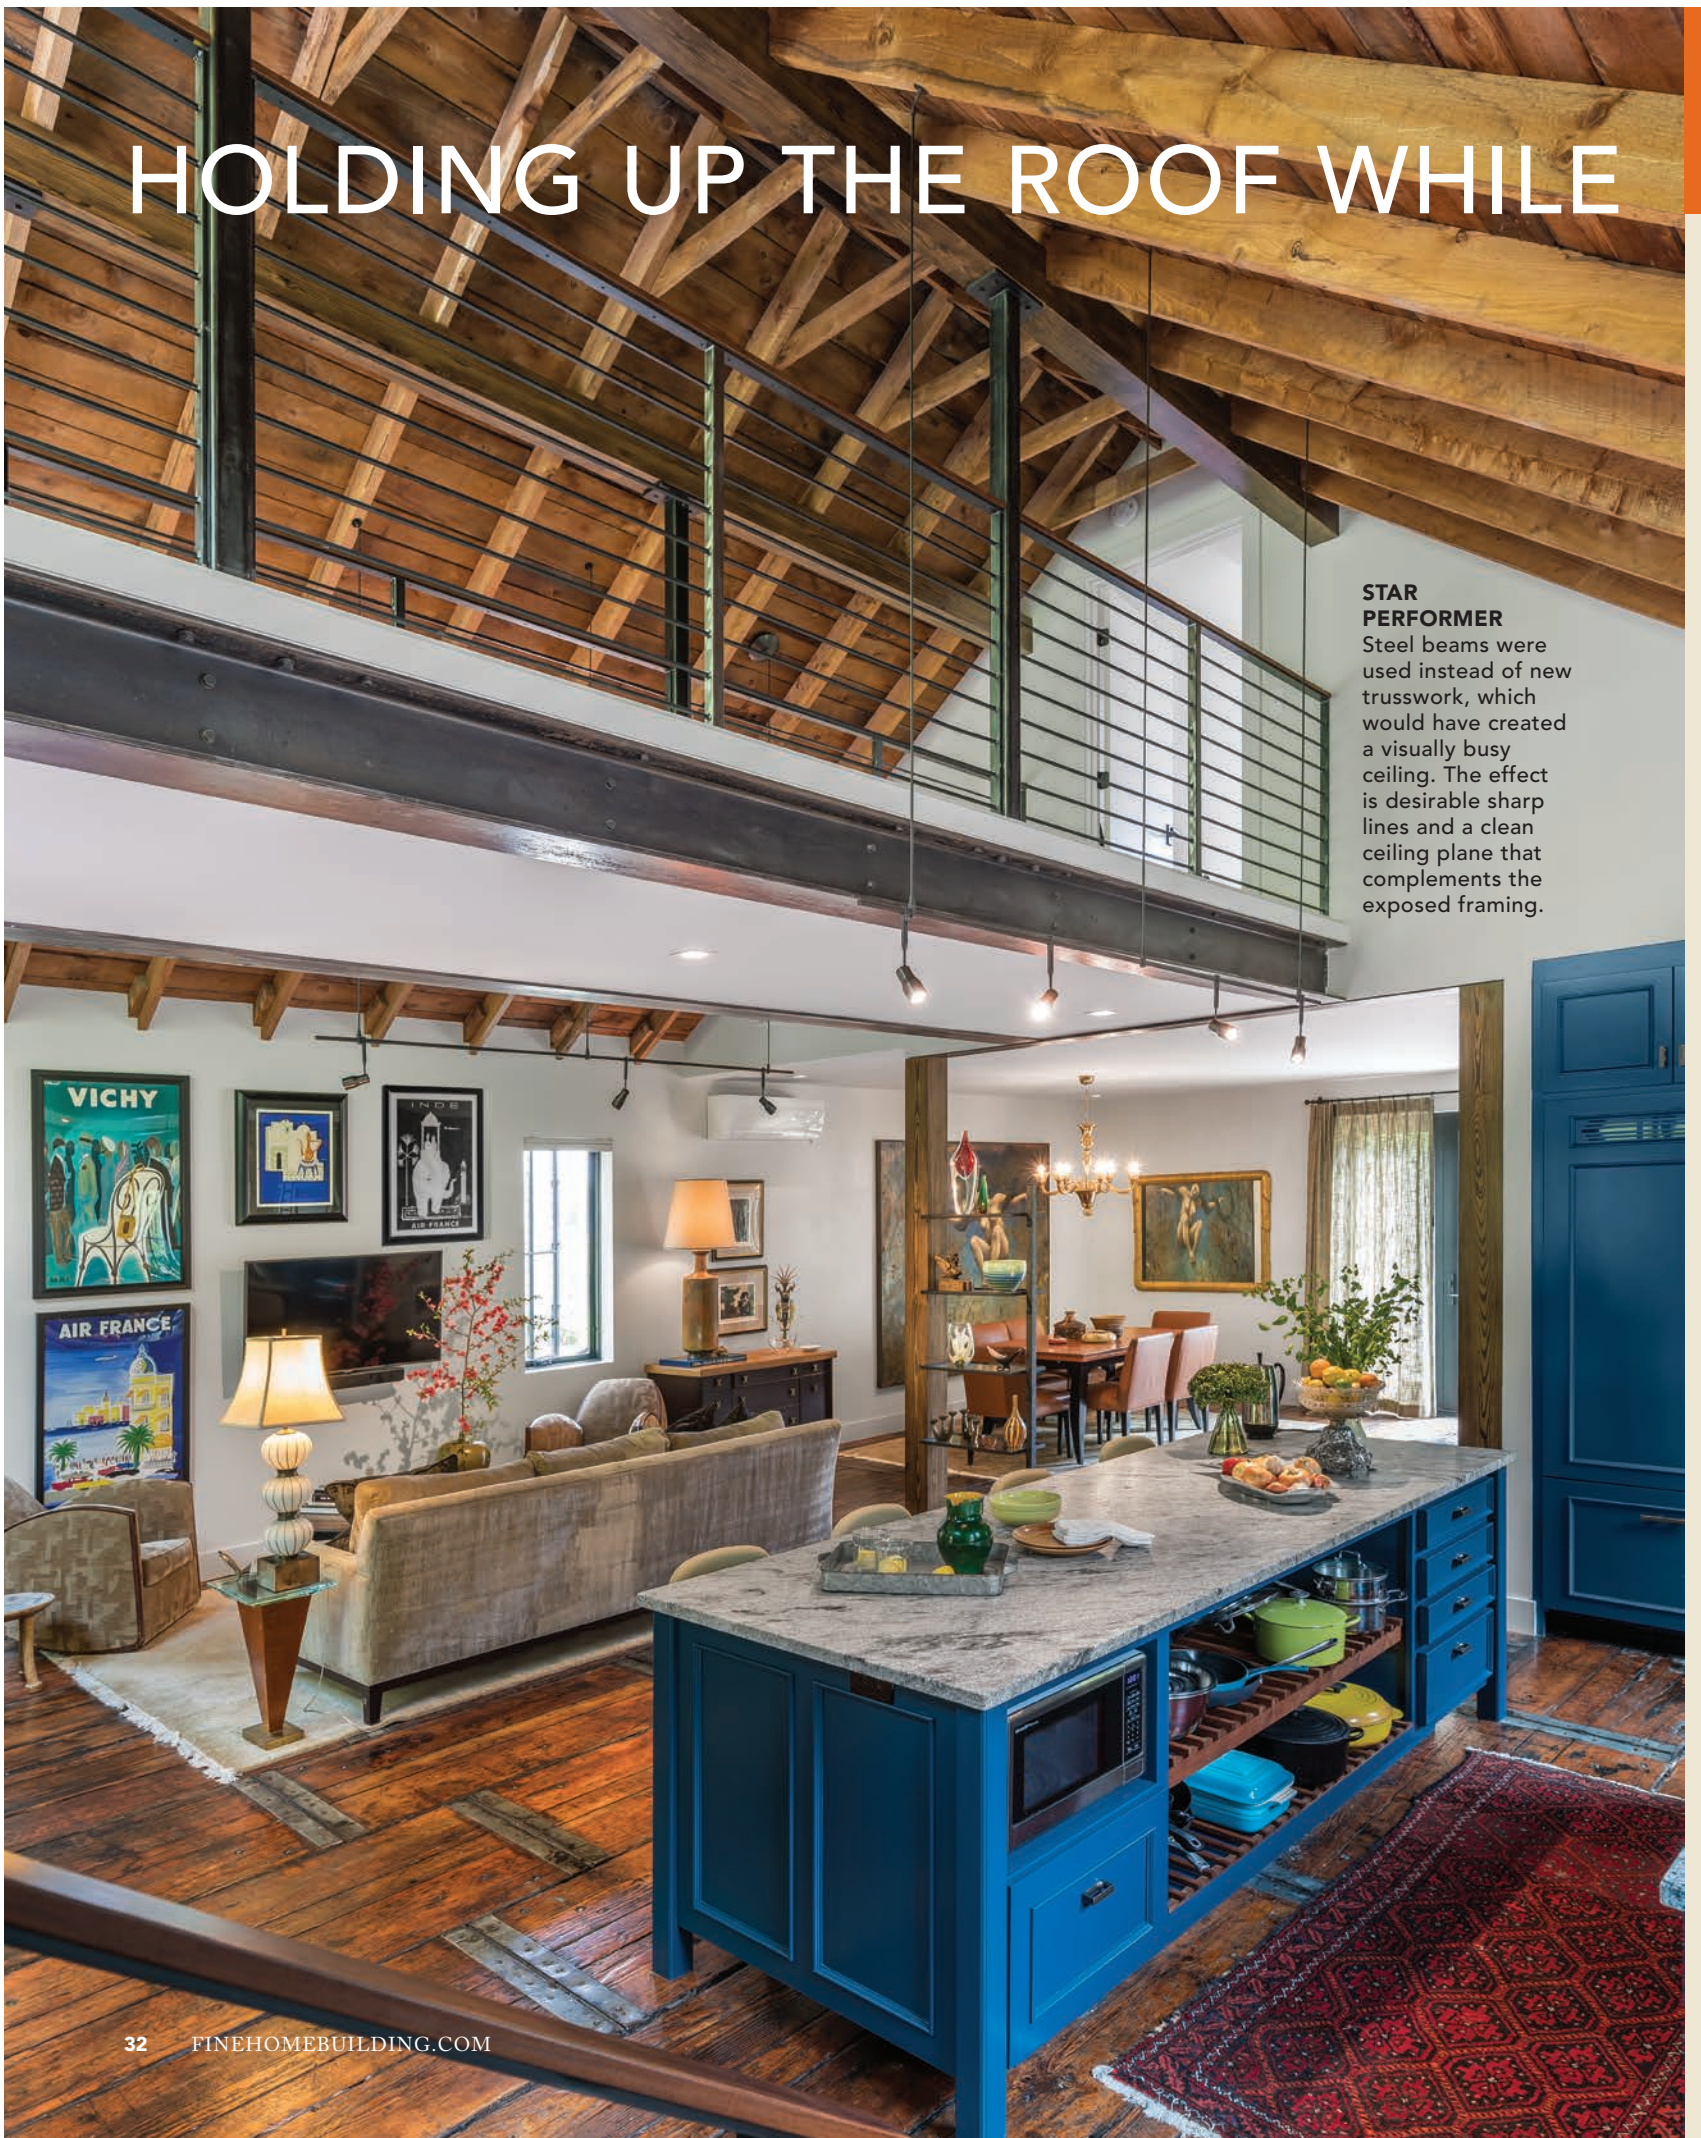
**STAR PERFORMER**  
Steel beams were used instead of new trusswork, which would have created a visually busy ceiling. The effect is desirable sharp lines and a clean ceiling plane that complements the exposed framing.

The original site-built roof trusses were undersized and had a significant sag; plus, they created a visually dizzying interior space that the homeowner wanted cleared. The catwalk was similarly underbuilt—but the catwalk was part of what sold the owner on the building. So the trusses had to go, and the catwalk had to stay.

The solution was to use the new catwalk structure to support the roof framing. The first big move was to support and jack the top cord of the trusses, while also plumbing the exterior walls. The crew built a support and jacking system by installing temporary beams at the midspan of the top cord with posting locations that fit through the existing trusses of the roof structure. As they jacked the sag out of the roof, they used turnbuckle bracing on the walls to pull and push them straight and as plumb as they would go. Using the temporary beam as a top plate, they built a braced temporary wall from floor to ceiling so that they could then remove the truss webs and bottom cords, leaving the top cords as rafters. The crew had to do all of this work without damaging the structure's "patina"—the aged look the homeowner was keen to retain.

Two 24-ft.-long steel I-beams were installed for the catwalk structure, supported by timber posts that have a load path to footings under the slab. Two new laminated wood beams on either side of the ridge were let into the rafters with the use of birdsmouth cuts; the beams break the span of the rafters and are supported by steel posts that drop to the I-beams, making the catwalk the new structure for carrying the roof load. In one section of the roof, the bottom chords of the trusses were replaced with new floor joists for a new loft bedroom.

Getting 1000-lb. prefinished steel I-beams into the house and installed was a big challenge. To get the job done, the team fed the new beams in through the existing gable doors with a telehandler and carts on the first floor. Then they removed two panels of the existing metal roof and carefully cut out roof-sheathing boards to create access holes for the lifting straps used by the telehandler outside to lift the beams into place. (They cut the sheathing where it passed over the existing rafters so that the cuts wouldn't be visible on the inside when the pieces were reassembled.) Handling the beams' massive weight while protecting all finishes from damage was a test of patience. The inside crew communicated with the operator outside via cell phones and headsets.

This construction nail-biter is now one of the home's most arresting features. The steel beams anchor the volume both physically and visually. Together with the new wood beams and preserved rafters and board sheathing, they contribute to a solid new building shell and the homeowner's desired milieu.

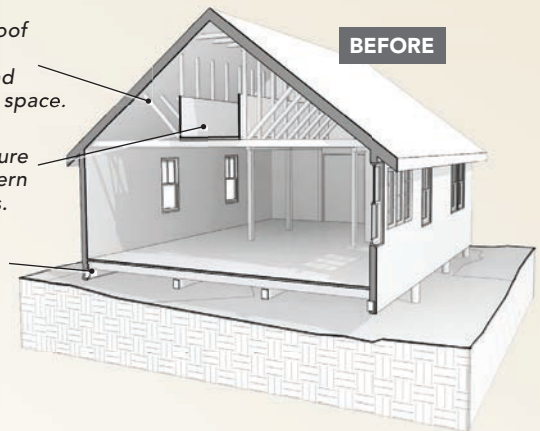
The original roof trusses were undersized and cluttering the space.

The catwalk structure did not meet modern code requirements.

The old pier-and-beam foundation was in poor condition.

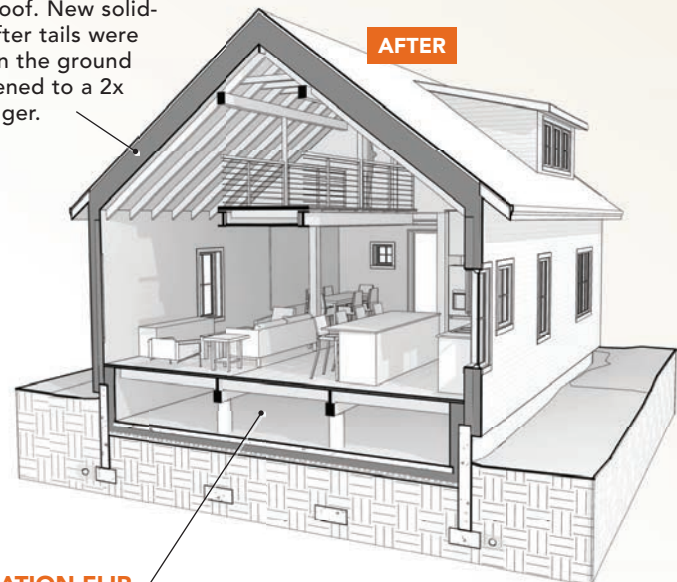
## ROOF REDO

The homeowner wanted the original board roof sheathing exposed on the interior, so the build team removed the metal roofing and built a new, vented roof assembly over the old roof. New solid-wood rafter tails were precut on the ground and fastened to a 2x soffit ledger.

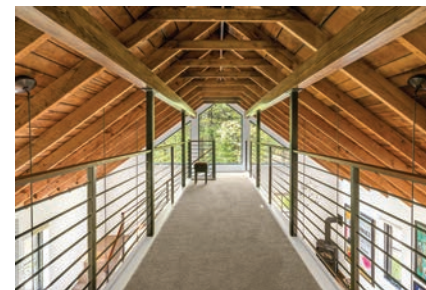
**CATWALK REVIVAL** The catwalk runs from a new east-corner bedroom to a set of polygon-shaped windows looking onto a wooded view at the rear of the house.

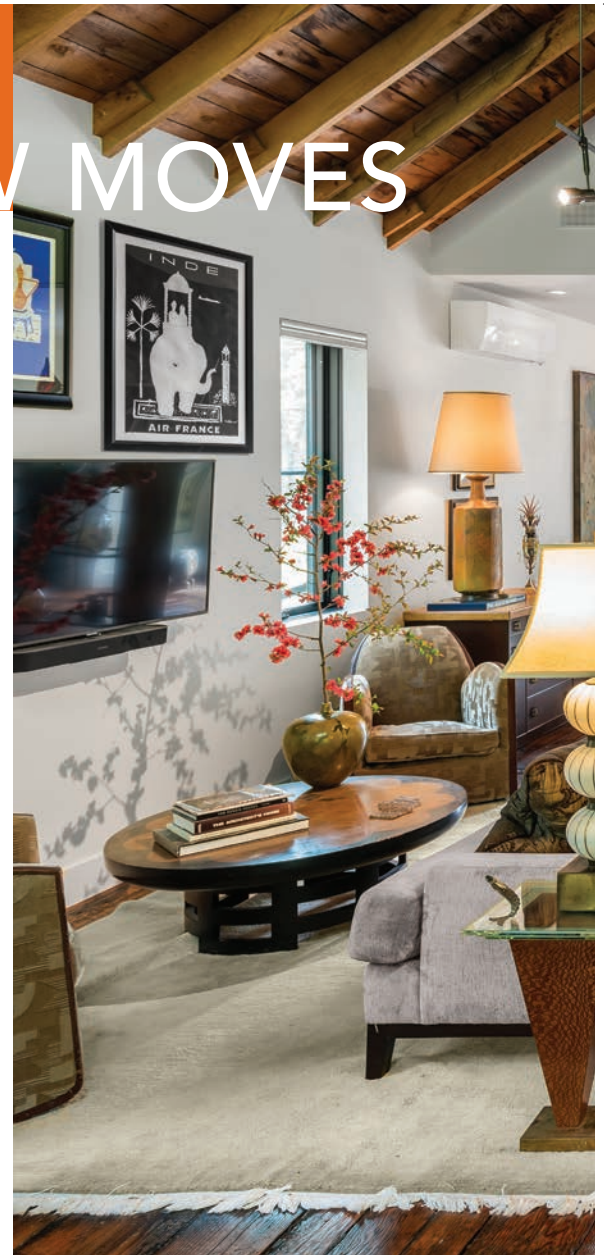
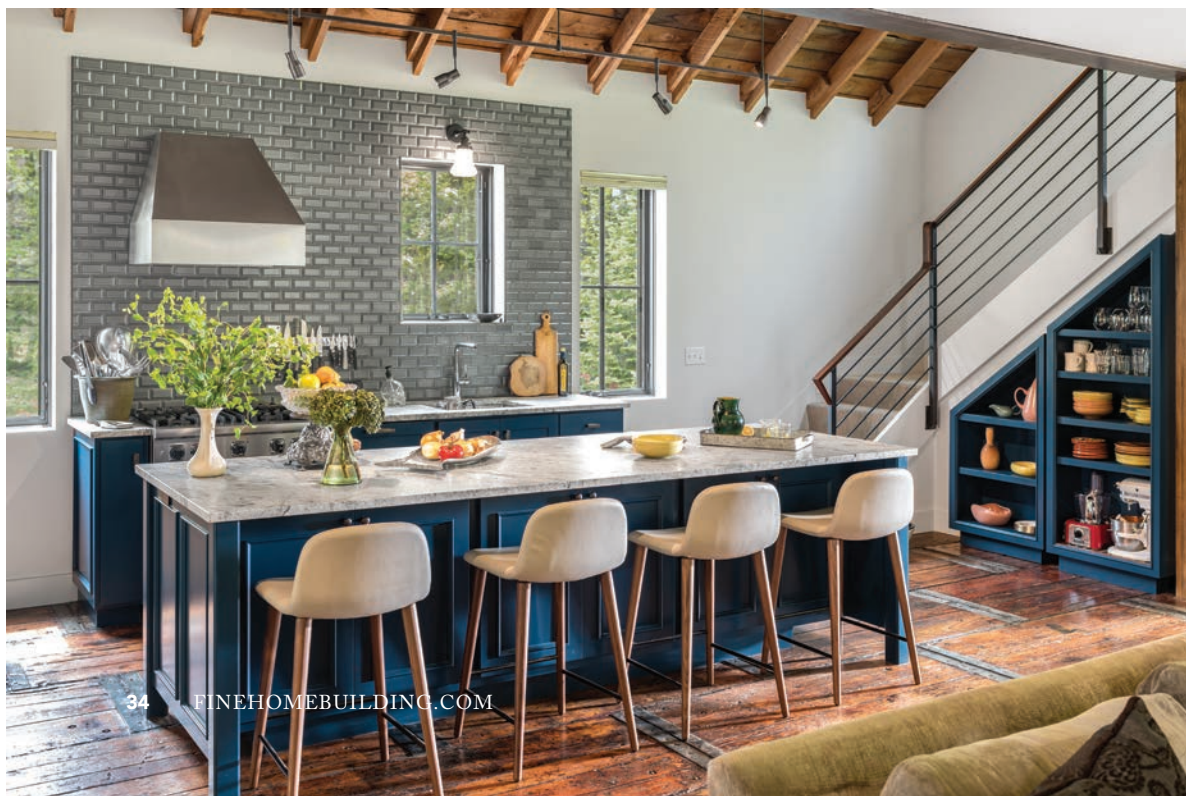
**RAFTER TALES** The “scabbed on” rafter tails were left in place when the original rafter tails were cut off on the exterior. Removing them risked cracking a rafter, or at the least, revealing a patch of mismatched wood. The finished drywall was cut around each of these tails and flat-taped for a clean look.

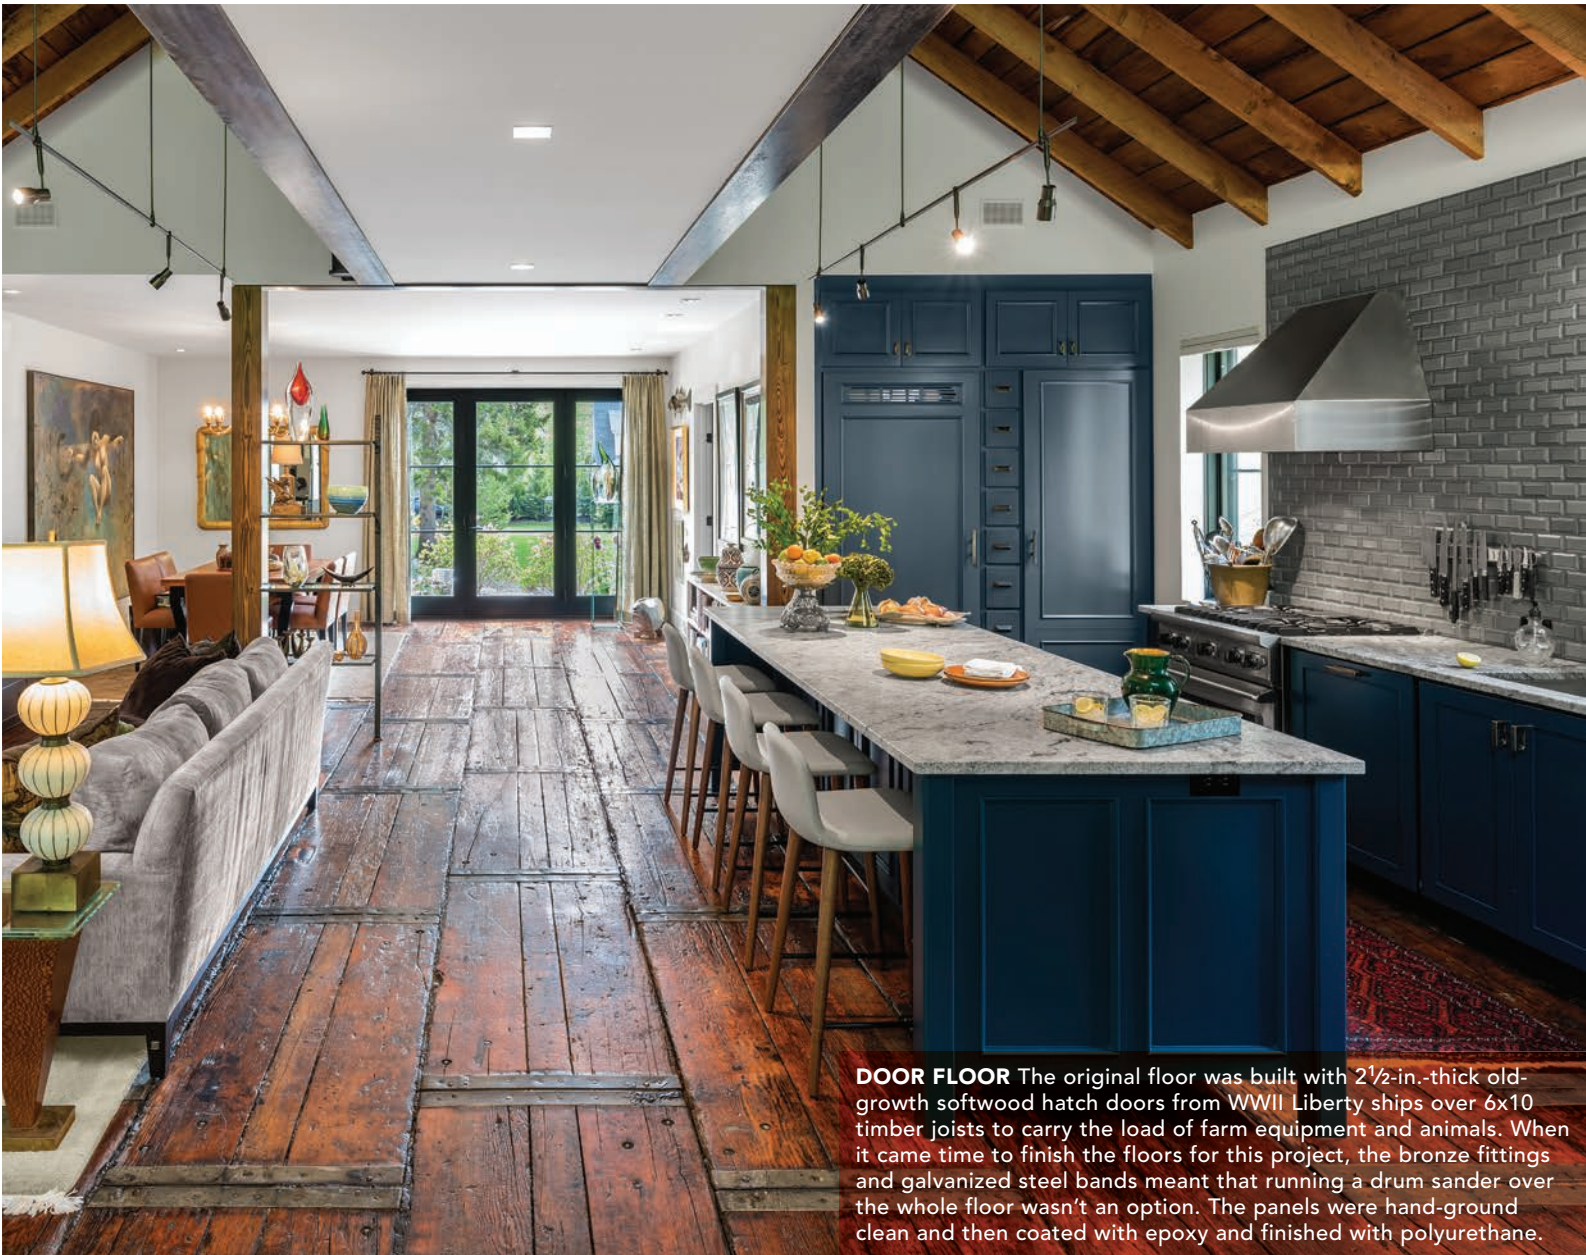
**DOOR FLOOR** The original floor was built with 2½-in.-thick old-growth softwood hatch doors from WWII Liberty ships over 6x10 timber joists to carry the load of farm equipment and animals. When it came time to finish the floors for this project, the bronze fittings and galvanized steel bands meant that running a drum sander over the whole floor wasn't an option. The panels were hand-ground clean and then coated with epoxy and finished with polyurethane.

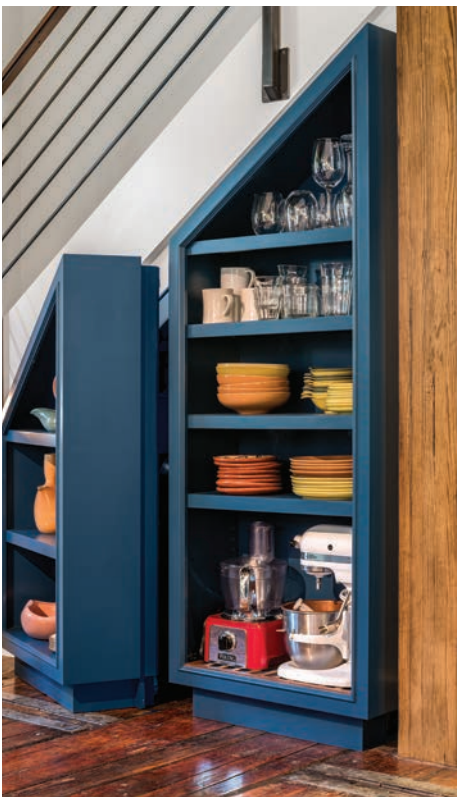
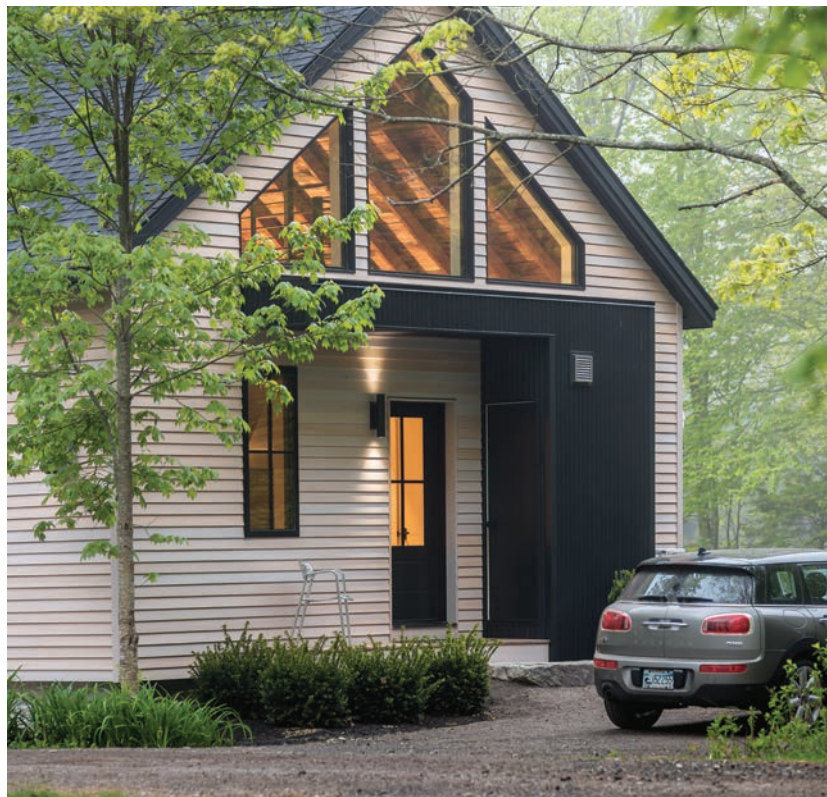
**REVISED EDITION** From a distance, the clapboard siding mimics the original barn's siding to stay in keeping with the neighborhood. Existing windows were replaced with Marvin Elevate triple-pane units—chosen for their minimal trim—which required installing window bucks. There are new patio doors on the east that replaced an old sliding barn door and modern gabled glass on the west.
